PORTSMOUTH GASEOUS DIFFUSION PLANT, X-720
MAINTENANCE AND STORES BUILDING
3930 U.S. Route 23 South
Piketon vicinity
Pike County
Ohio

HAER OH-142-Y
HAER OH-142-Y

WRITTEN HISTORICAL AND DESCRIPTIVE DATA

<u>Present Use:</u>	The X-720 Maintenance and Stores Building is used for process and auxiliary equipment maintenance, as a storage area for spare parts and maintenance equipment, and for equipment testing and inspection.
<u>Significance:</u>	The X-720 Maintenance and Stores Building is used for a variety of shop activities, offices, and storage of parts. The building is also used for the testing and inspection of process and auxiliary equipment. This building is part of PORTS, which was a part of the U.S. Cold War nuclear weapons complex. PORTS' primary Cold War era mission was the production of highly enriched uranium by the gaseous diffusion process for defense/military purposes.
<u>Project Information:</u>	Fluor-BWXT Portsmouth LLC photographed the site in August 2014. Gray & Pape, Inc., Cincinnati, Ohio, served as the primary author of the historical narrative and resource descriptions drawing from numerous historical records and reports, drawings, photographs and plans. For a

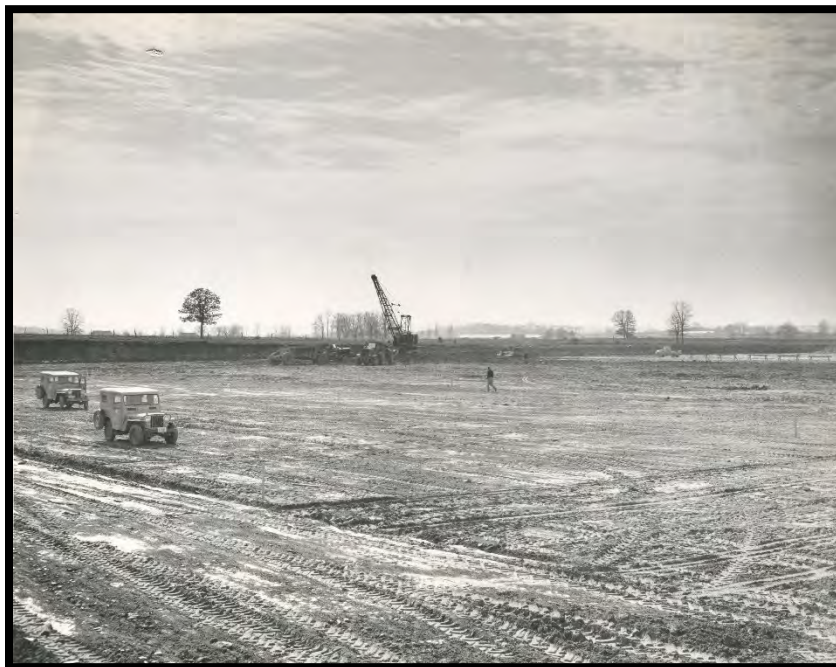
Figure 4: Grading Work for the X-720 Maintenance and Stores Building,
February 1953

Excavation work commenced in March 1953 (Appendix B, Figure 4). As elsewhere on the plant site, workers encountered difficulties with "fat clay," forcing them to conduct test borings to determine how much earth would have to be removed to reach a solid bearing. Fat clay is a term used to describe clay with a high plasticity. Workers encountered it throughout the area during construction. Due to its plasticity, it makes for an unstable foundation. Workers countered this problem by excavating the fat clay until they reached a more solid subsurface. This necessitated infilling with concrete and stable fill material. Ultimately, workers excavated 80,000 cubic yards of earth in preparation of pouring concrete.

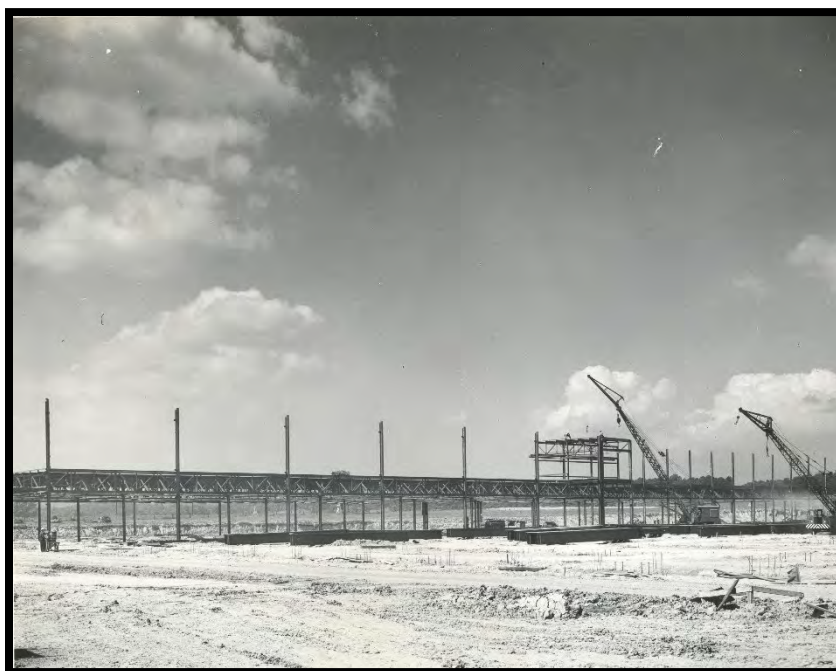
Figure 5: Steel Framing for the X-720 Maintenance and Stores Building,
May 1953

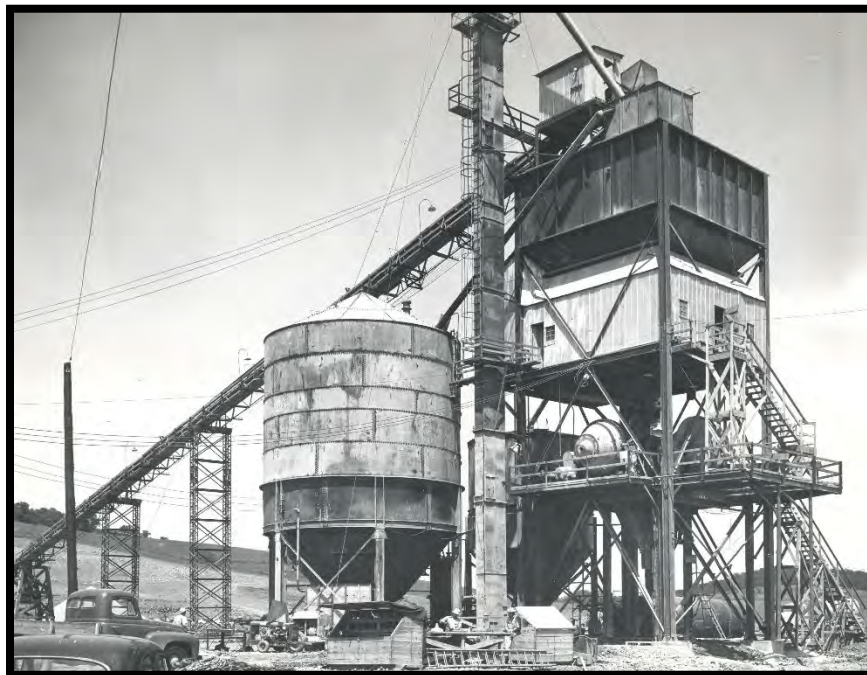
Figure 6: Batch Plant for the X-720 Maintenance and Stores Building, May 1953

Concrete work began in early April 1953. The concrete contractor erected a mixing plant onsite (Figure 5). The floors and footers required 14,300 cubic feet of Class A concrete, which has a mixture strength of 3,500 pounds per square feet. The contractor completed all concrete work by late November 1953. Atop the concrete slab, steel workers from Crawford Steel Corporation, of Cincinnati, Ohio, began erecting the structural members for the building (Figures 6 through 11). Steel erection began in May 1953 and continued until the end of September 1953. Unlike the larger process buildings, which relied on bolted connections, plans for the X-720 Maintenance and Stores Building called for riveted connections.

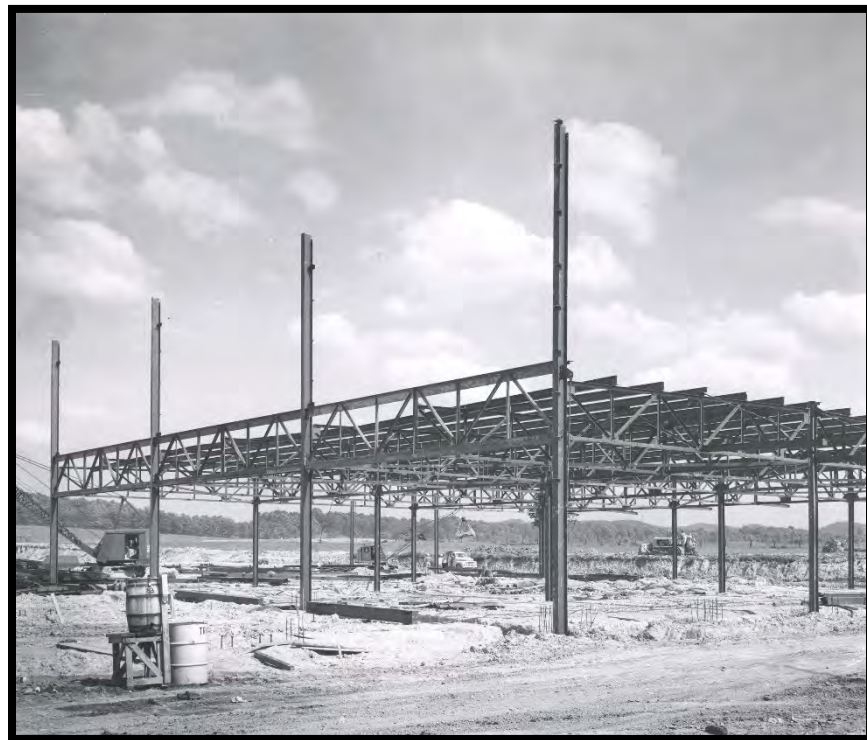
Figure 7: Steel Framing for the X-720 Maintenance and Stores Building, May 1953

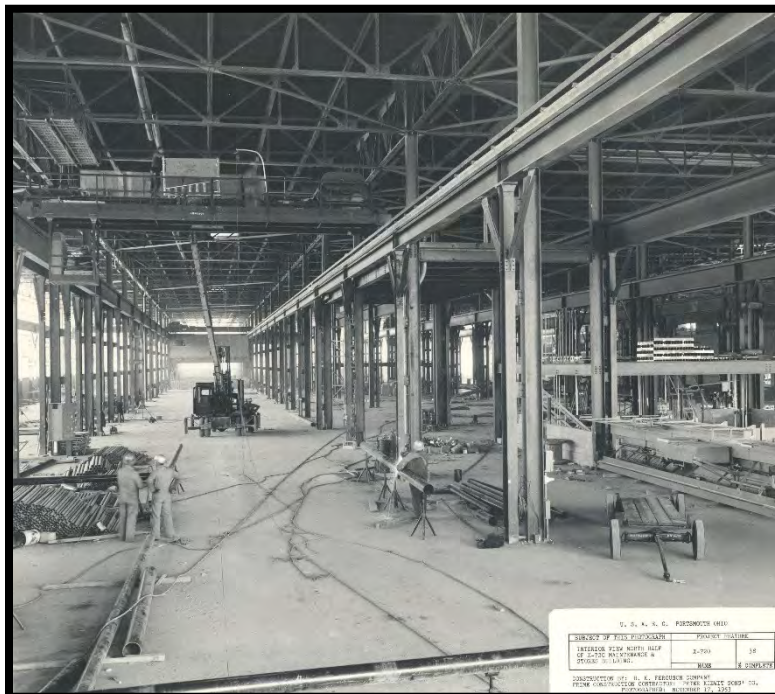
Figure 12: Looking North at the Interior of the X-720 Maintenance and Stores Building, November 1953

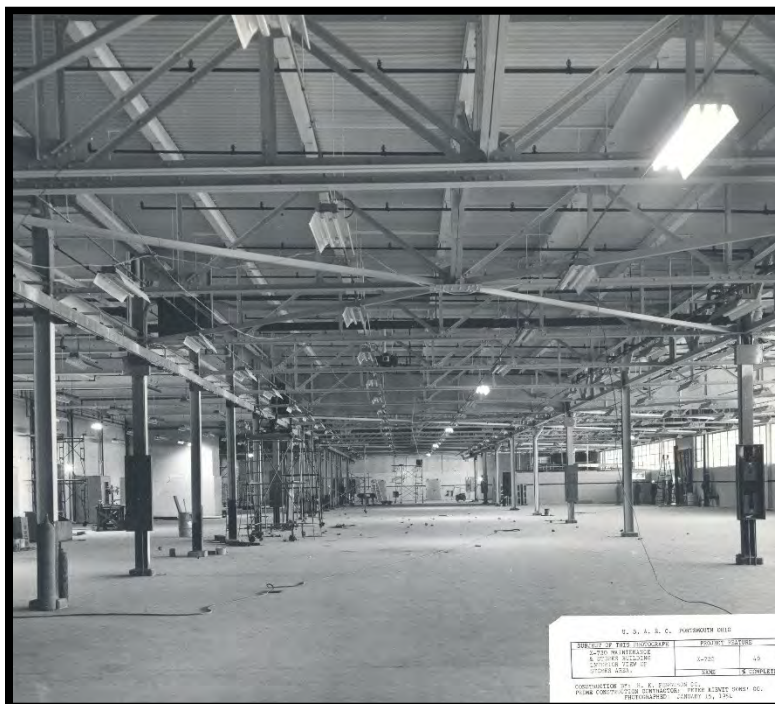
Figure 14: Interior View of the Stores Area of the X-720 Maintenance and Stores Building, January 1954

H. K. Ferguson Company contracted for the roofing work (Figures 14 and 15). They in turn subcontracted with Hunt Construction Company, of Indianapolis, Indiana, who began installing the steel roof deck in June 1953. By the end of November 1953, they had completed installing the 2,840 square foot roof. The Industrial Roof and Sheet Metal Company, also under subcontract with H. K. Ferguson Company, was in charge of the built-up roof work.

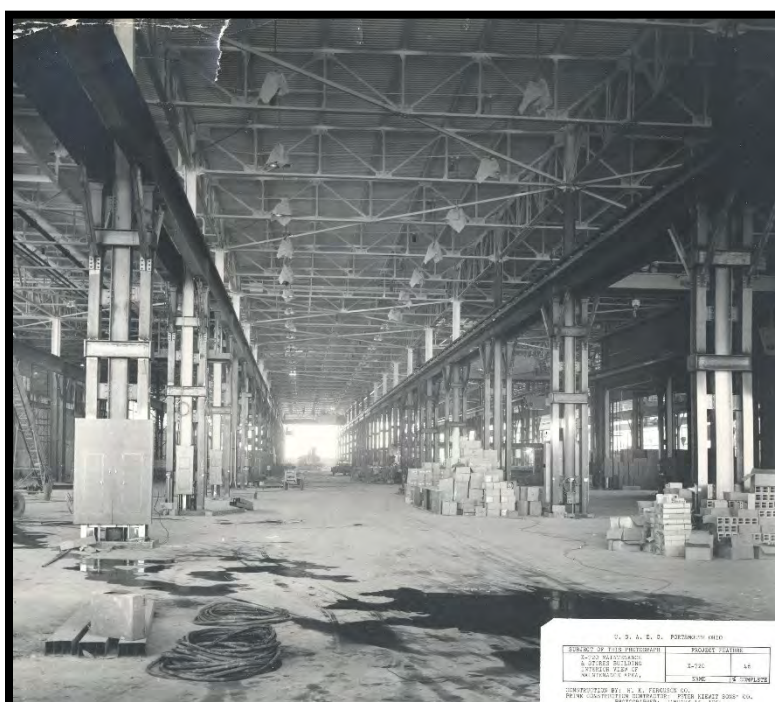
Figure 15: Interior View of the X-720 Maintenance and Stores Building, January 1954

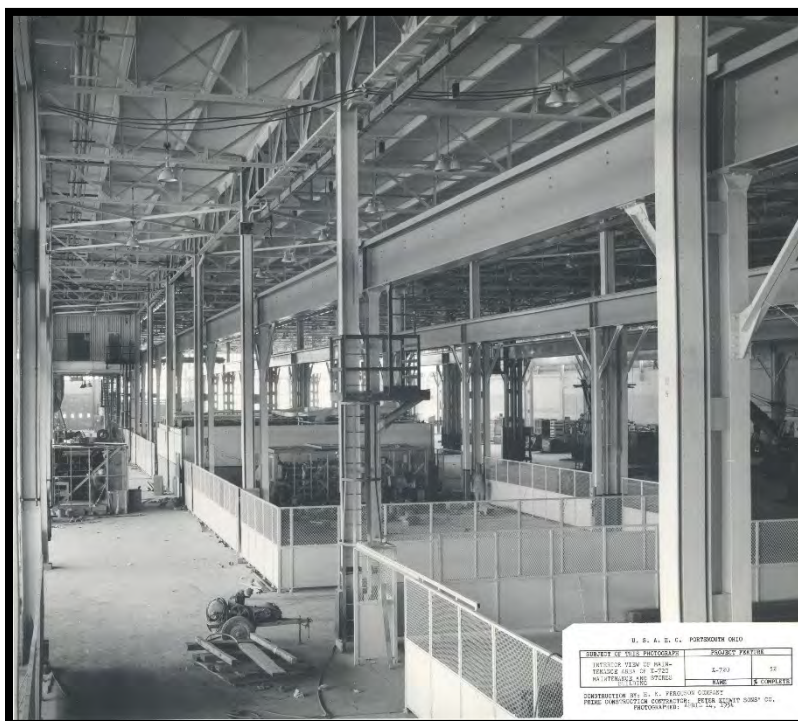
Figure 19: Interior View of the Maintenance Area of the X-720 Maintenance and Stores Building, April 1954

June 1953 and completed the job in May 1954. Subcontractors of H. K. Ferguson Company installed the mechanical systems, including the plumbing, heating and ventilation, elevators, cranes, sprinkler systems and other items (Figures 16 through 23).

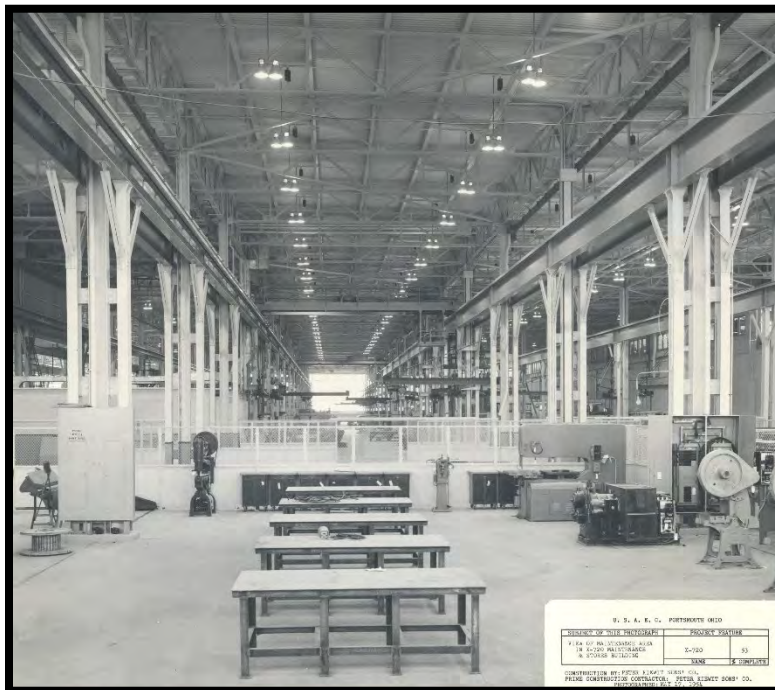
Figure 20: View of Maintenance Area in the X-720 Maintenance and Stores Building, May 1954

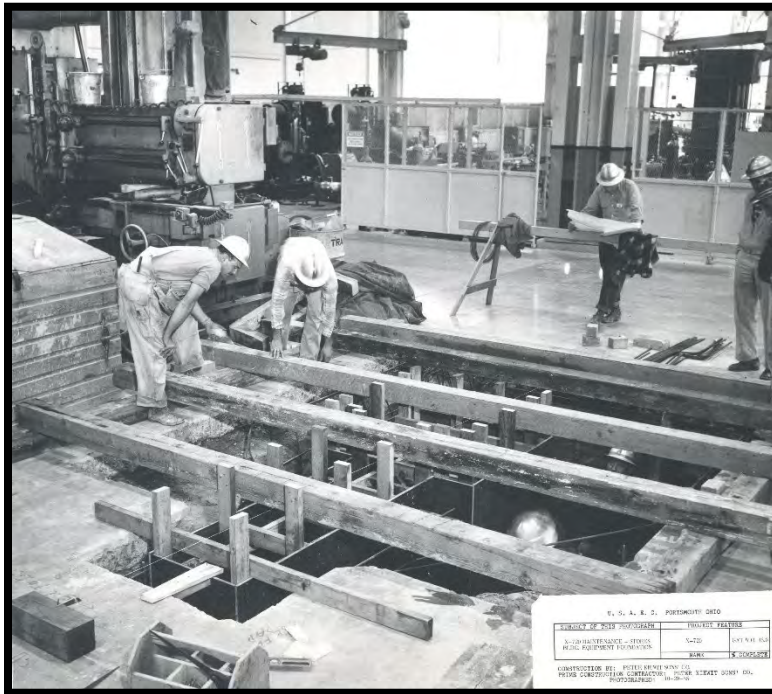
Figure 22: The X-720 Maintenance and Stores Building Equipment Foundation, October 1955

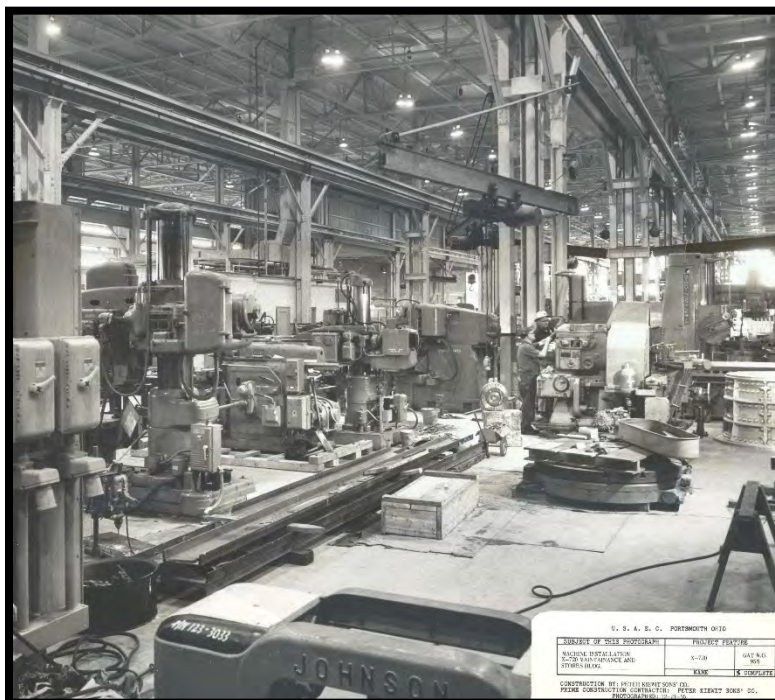
Figure 23: Machine Installation in the X-720 Maintenance and Stores Building, December 1955

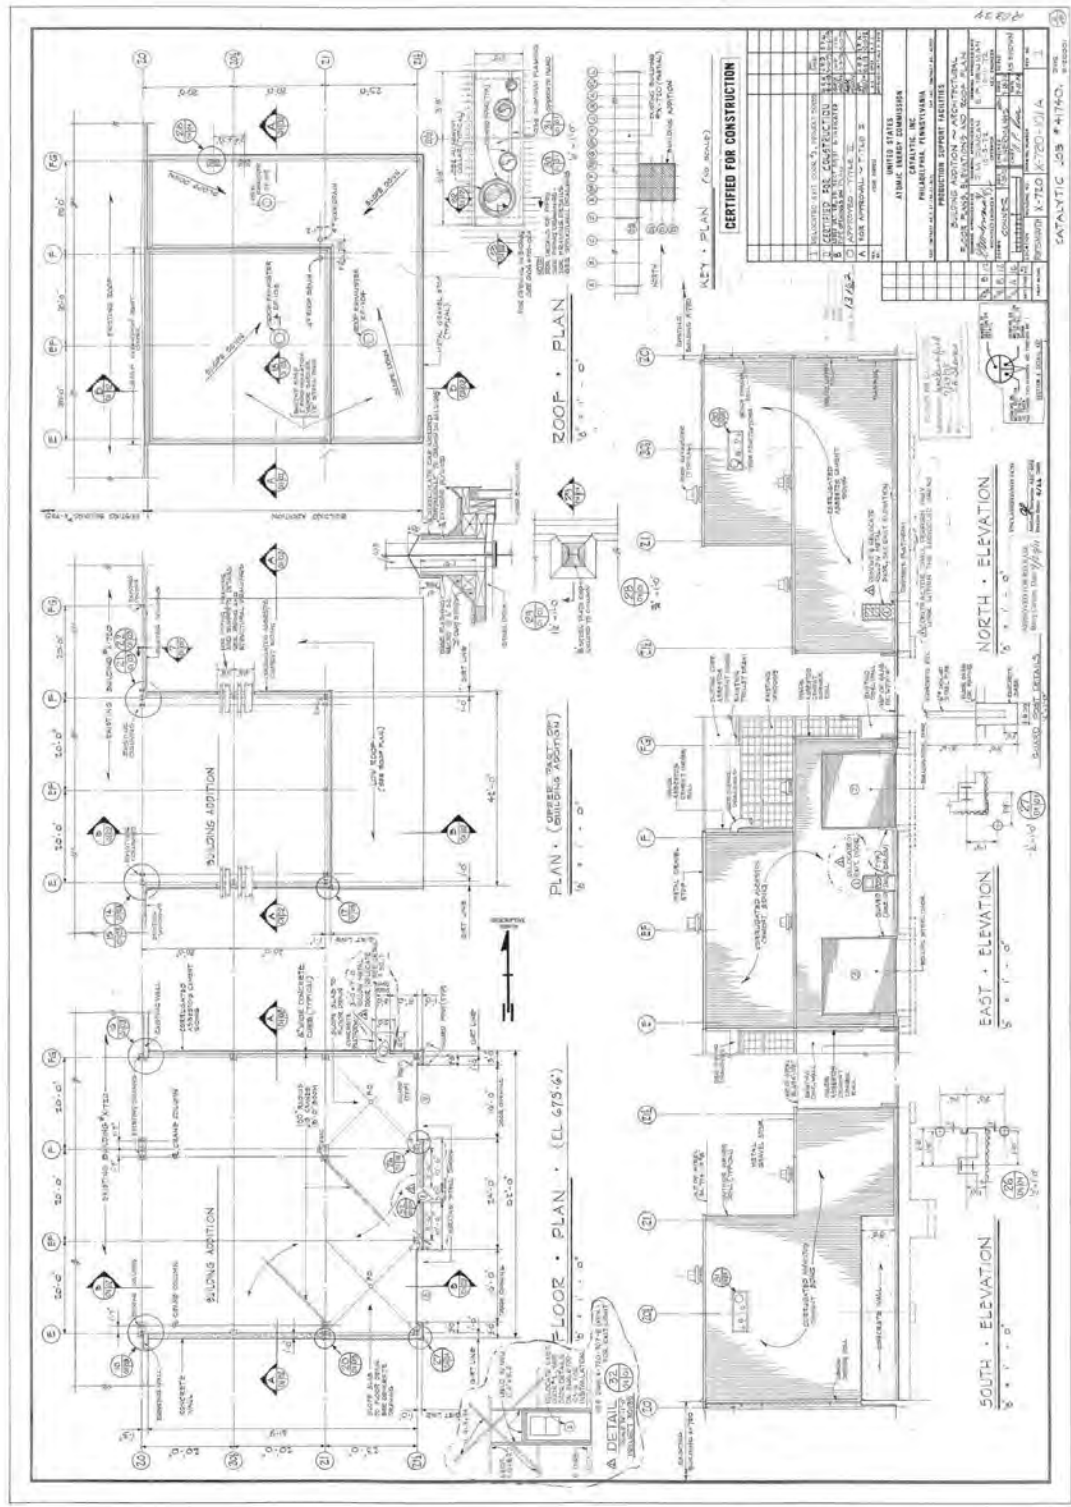
Figure 24: Floor Plans, Elevations, and Roof Plan

Historical drawings of building plans are provided in Appendix C (Figures 24 through 30).
